# **Commercialization of Technologies to Lower Defense Costs**

## **Final Demonstration/Validation Report For STAPP Bullet Catcher Evaluation at Fort A.P. Hill**

**March 2, 2006**

Report Number: NDCEE-CR-2006-001

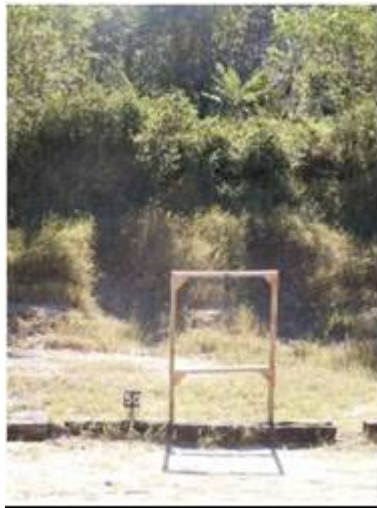
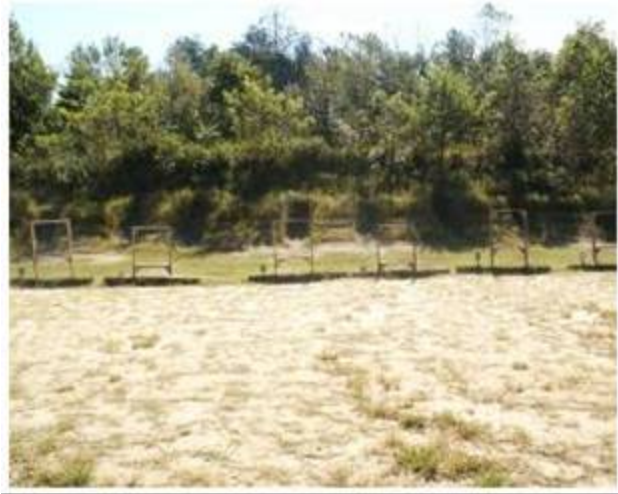
The initial physical condition of the Range 4 berm is best depicted in Figures 1 and 2. Large craters, created from years of firing, are clearly visible. The craters were formed as a result of bullets penetrating the soil and eroding the berm. The craters in the near vicinity of the Bullet Catcher are approximately 80 inches long x 52.5 inches wide x 12 inches deep. There is woody vegetation present for the prevention of soil erosion.

**Figure 1. Original Condition of Range 4 Close-up.**

**Figure 2. Original Condition of Range 4.**

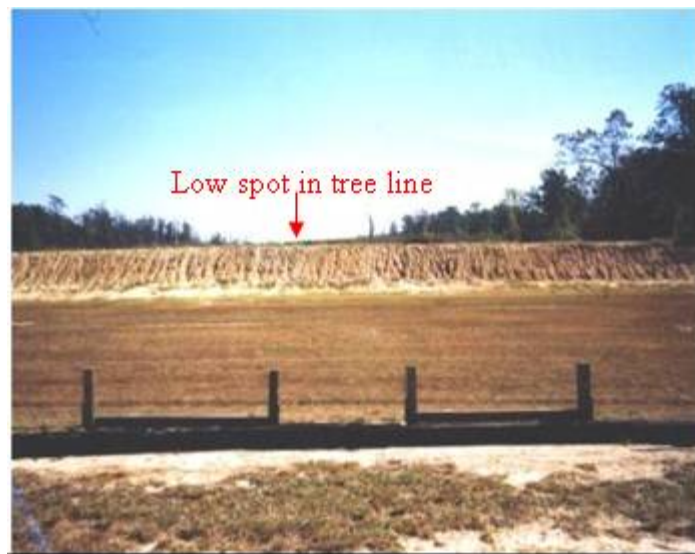
The physical condition of the Range 5 berm is best depicted in the Figure 3. Range 5 does not have any craters similar to the ones seen on Range 4 and has little, if any, woody vegetation or plant life. Erosion of the soil has created deep ruts on the face of the berm. There is also a large distance (271 feet, 6 inches) between the firing point and the berm, which allows bullets to “travel” upwards and beyond the height of the berm. By the observing the surrounding tree line and plant growth, it is obvious that bullets pass over the berm, cutting down trees and plant-life. This is shown clearly in Figure 3.

**Figure 3. Original Condition of Range 5.**

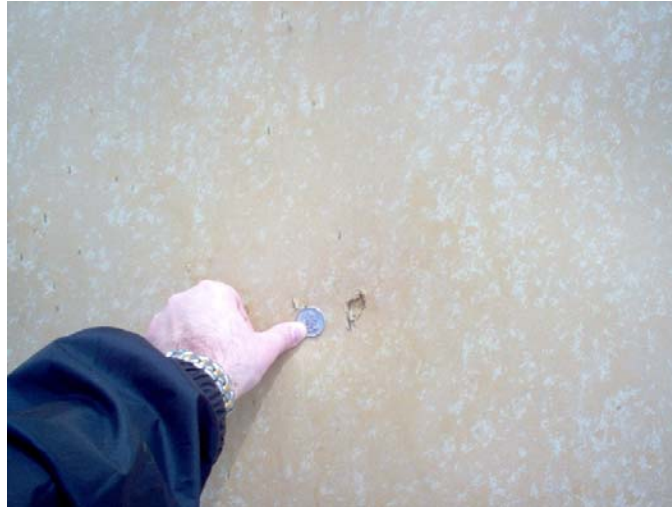
The top rubber cover had a small v-shaped tear approximately the size of a US quarter (See Figure 33). There was not a gaping hole, just a tear. It is believed that a tumbling bullet that had hit the target frame prior to the top rubber cover caused the tear. Mr. Mike Hargett of BAHF Training Group determined that no maintenance repairs were necessary at this time.

**Figure 33. Tear in Top Rubber Cover, Approximately the Size of a U.S. Quarter.**

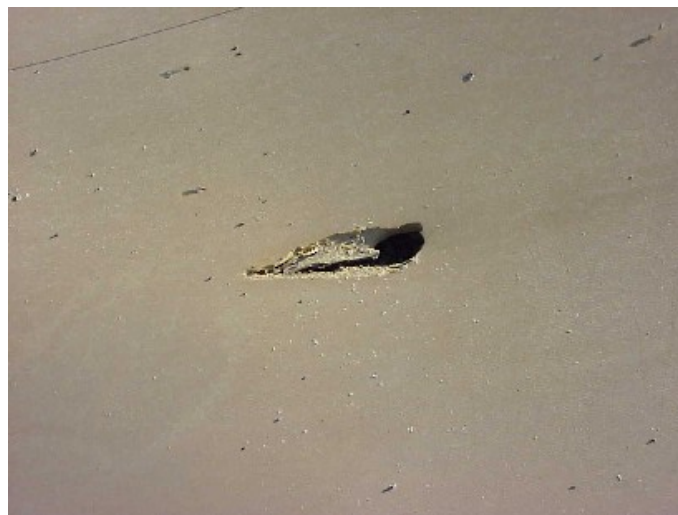
On 29 April 2004 all parties met at Range 5 to observe a small area on the left side of the Bullet Catcher that required patching (See Figure 34).

**Figure 34. Damage on Left Side of Range 5.**

Steps taken to repair the damaged area included sanding the perimeter of the damaged area and wiping it clean using rubbing alcohol. The repair patch

consisted of the very same material as the top rubber cover and was cut slightly larger than the damaged area to allow an approximate 1-2” overlap. The overlap provides a sound surface for the repair patch to adhere to. The under side of the repair patch was also sanded and cleaned with rubbing alcohol. Once the damaged area and patch were sanded and cleaned, a bead of the STAPP supplied glue was placed on both the perimeter of the damaged area as well as the coordinating under side of the patch. The patch was laid on top of the damaged area and hand-pressure was applied. The time required to complete the repair was approximately 5-7 minutes. For repair results see Figure 35.

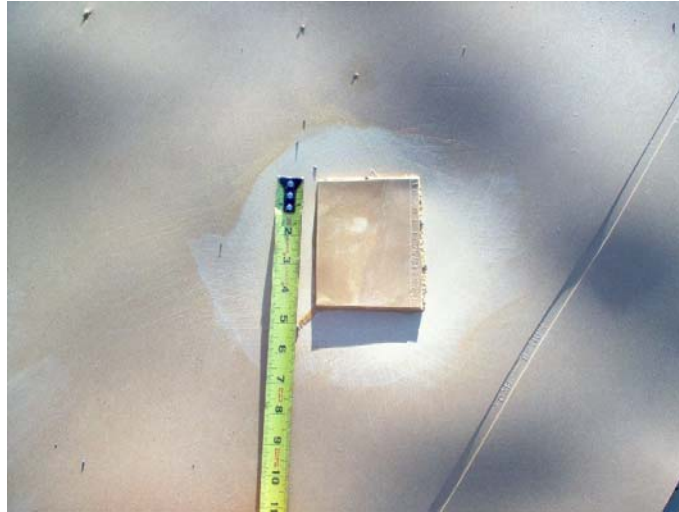
**Figure 35. Repair Patch to Damage Depicted in Figure 35.**

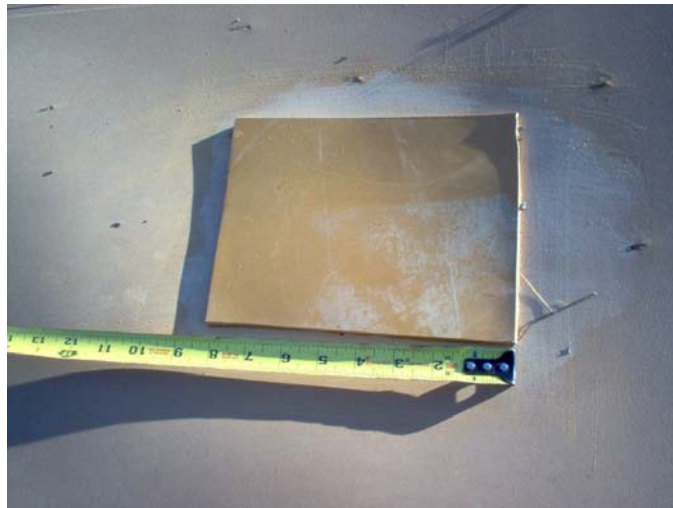
**Figure 36. Top Rubber Cover Patch on Right Side of Range 5 Bullet Catcher.**

There was a larger area of the top rubber cover on the right side of the Bullet Catcher that required patching as well. The very same steps taken to repair the smaller area on the left side were followed. The repair took approximately 5-10 minutes to complete. For results see Figure 36.

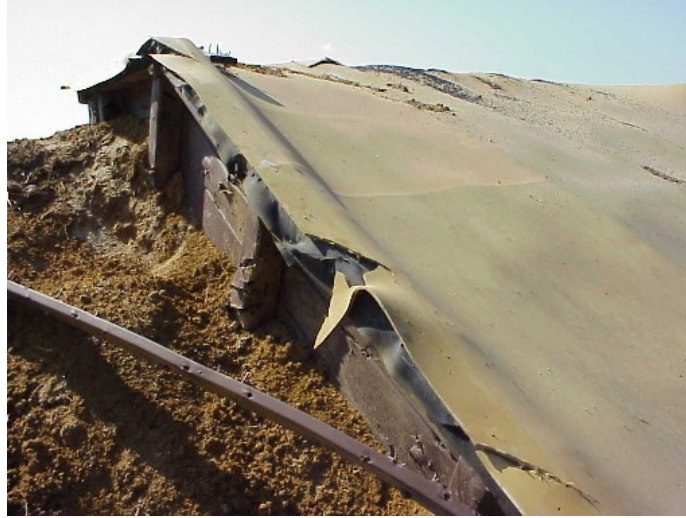
There was also damage along the left side of the Bullet Catcher just inside of the frame/planking, see Figure 37, which required the same repair steps previously mentioned.

**Figure 37. Left Side Damage to Top Rubber Cover and Frame/Planking on Range 5.**

The frame/planking was also damaged and a section needed to be replaced. After a replacement plank was cut to size it was screwed into place. The patch and plank replacement took approximately 25-30 minutes to complete.

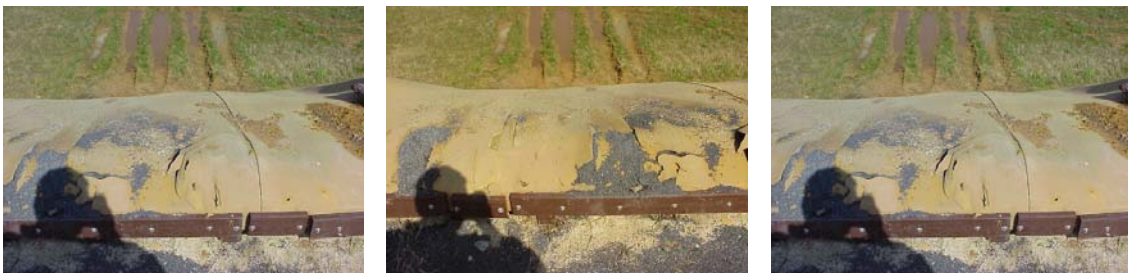
The top of the Bullet Catcher had severe damage to the upper portion of the top rubber cover (See Figures 38, 39, and 40).

**Figures 38, 39, and 40. Damage to the Upper Portion of the Top Rubber Cover of the Range 5 Bullet Catcher.**

The bullets hit the top portion of the Bullet Catcher because of the long distance between the firing point and the Bullet Catcher (approximately 271'). This large distance allows bullets to "travel" to the edges of the Bullet Catcher and beyond. Bullets that impact the Bullet Catcher at or near the edges are not able to penetrate the Bullet Catcher properly and therefore cannot be appropriately retained. The top portion of the Bullet Catcher, where it becomes flat, showed the most damage. Bullets that were fired at an upward angle or from the prone position caused this damage. When the bullets finally reach the Bullet Catcher they have traveled roughly 271' and have had the opportunity to "climb". The bullet then lightly penetrates the flattened out portion of the Bullet Catcher and simply skims the top rubber cover, tearing it as it passes. This damage is not due to a malfunction or inadequacy of the Bullet Catcher to perform, but is a direct result of the range design. Perhaps if the Bullet Catcher had been designed and constructed several feet taller this damage would not be an issue.

The top portion of the Bullet Catcher was patched. Steps taken to repair the damaged area were the same as for the smaller patches. Two large repair patches were needed for this top portion. Approximately 25-30 minutes were required to repair the entire top portion of the Bullet Catcher.

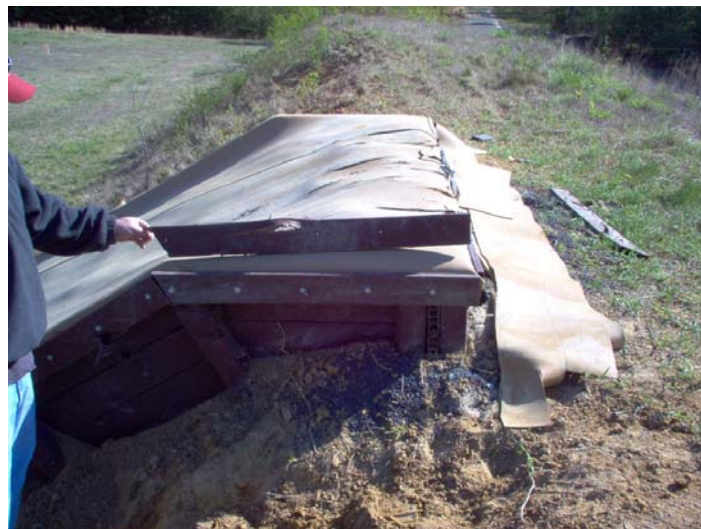
**Figure 41. Damaged Frame/Plank Above-Replacement in Place Below.**

There was also a small piece of planking on the top left corner as well as a small damaged area of planking on the top right corner that needed to be replaced (Figure 41 shows the replacement planking for the right side.). After each piece of replacement planking was cut to size it was screwed into place. These repairs required approximately 5 minutes per section to complete.

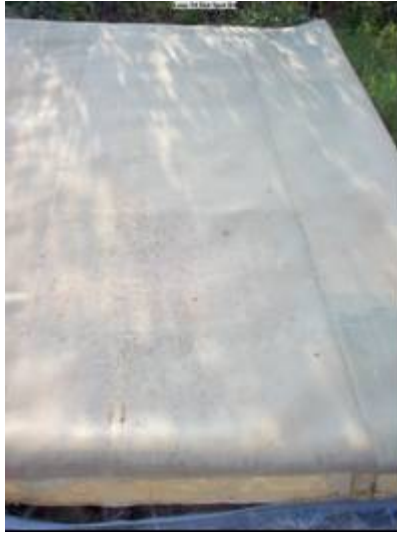
The bullets that impacted the Bullet Catcher on Range 4 were confined to “hot spots.” In this instance a hot spot is an area with a high concentration of bullets/entry marks. Each lane had a hot spot approximately 70” (height) x 50” (width) located towards the lower section of the Bullet Catcher (Figure 46).

**Figure 46. Range 4, Lane 54 Hot Spot.**

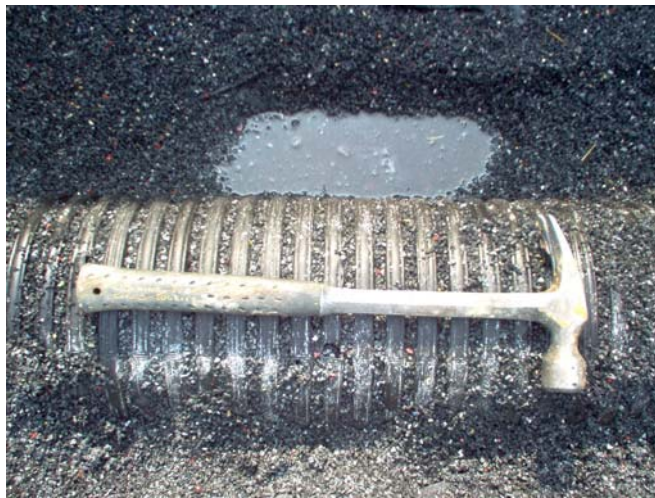
After the granular rubber was removed, it was noticeable that there was some water accumulation in the Bullet Catcher. A puddle of water, roughly one-half gallon, was lying next to the water collection pipe at Lane 53 (See Figure 50). This was an indication that precipitation had entered the Bullet Catcher, which would be sampled, analyzed, and properly disposed of.

**Figure 50. Puddle of Water at Lane 53.**

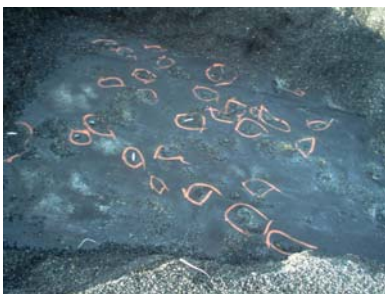
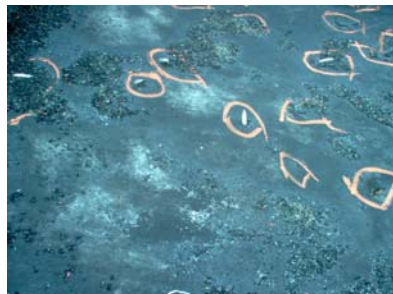
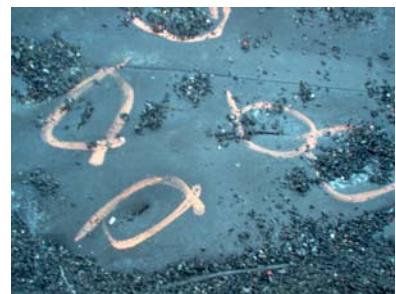
Again, Clean Harbors chose to utilize the STAPP-sifter during the sifting process. Range 5 had bullets throughout the depth of the granular rubber. Once the granular rubber was removed from the hot spot, the bottom rubber liner was visually inspected. Upon inspections it was noted that there were roughly thirty holes/tears in the bottom rubber liner caused by bullets penetrating beyond the depth of the granular rubber. Some of the holes/tears had bullets protruding from them with several facing away from the bottom rubber liner. For more detail please see Figures 53, 54, and 55.

**Figures 53, 54 and 55. Holes/Tears (circled) in Bottom Rubber Liner of the Range 5 Bullet Catcher.**
